2004 Naval Safety Center Aviation Maintenance Safety Conference NAS Norfolk, VA 27 - 29 April 2004

Onboard Oxygen
Generating System
(OBOGS)
Bill Struble

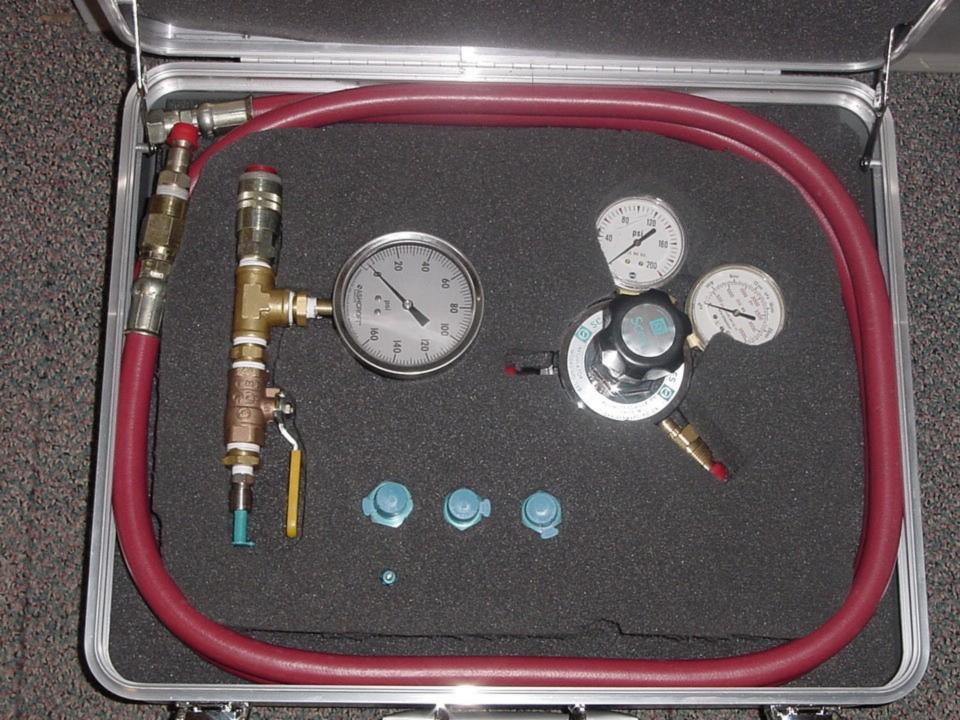
- COMFITWINGLANT and COMSTRKFITWINGLANT directed squadrons to perform a torque verification check to correct immediate (massive) leaks. That was followed up with a formal AFB (500).
- Inventory of available SE (74D470010-1001) to perform platform leak checks indicated an acute shortage (in cal, insufficient assets etc.)
- Basis for decision to field new OBOGS Leak Adapter Kit (3248AS 300-1)

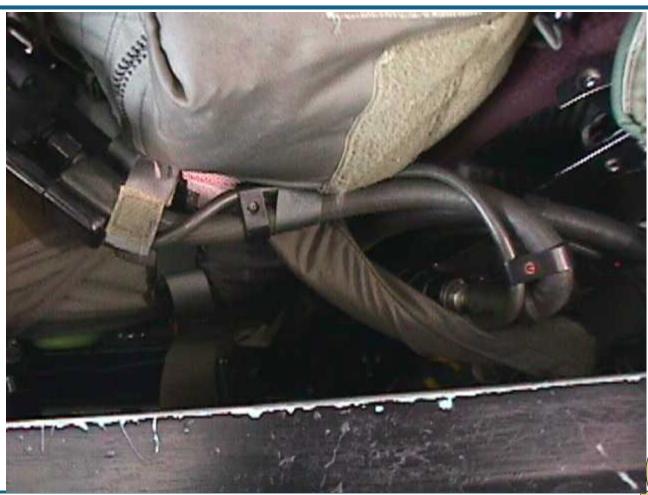
Results of investigations:

- Failures occurred due to stress and age
- Contributing factor:
 - Severe bend when Regulator Hose is connected to Survival Kit Hose while wearing SV-2
 - No defined Check and Test procedures or service life
 - Unacceptable twisting of hoses created during hook-up

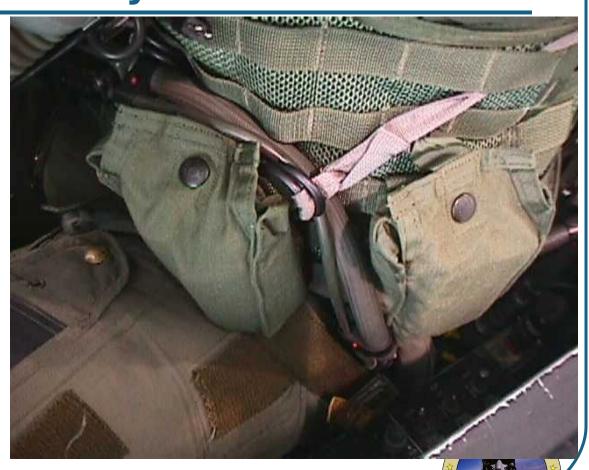
Results of investigations: (continued)

- Impact while crewmember is wearing AIRSAVE Vest was also evaluated
- Ability to adjust Regulator location eliminated the severe bend.
